## Synopsis V1.0

## HI SEE Test Report for the Hynix, Micron, and Samsung 4Gbit NAND Flash Memories

Test Date: 22 May and 12 Aug, 2007

Report Date: 10/29/07

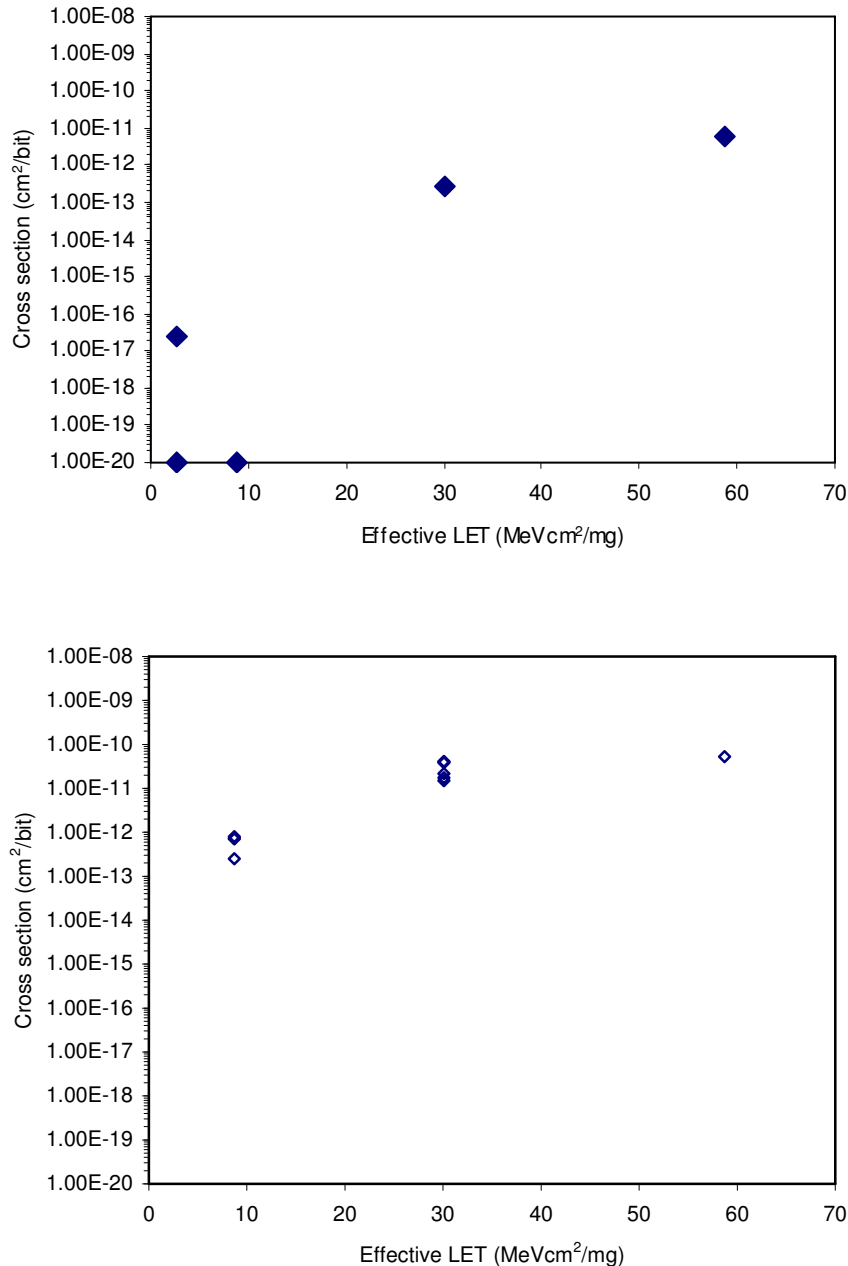
Fig. 4. Error cross-sections observed in static testing: (a) Micron; (b) Hynix.

During testing, the DUTs were irradiated with the ions indicated in Table I. The DUT was oriented normal to the incident beam, except as noted. The errors observed in static testing are shown in Fig. 4a for the Micron part, and Fig. 4b for the Hynix part.

Even for the static case, bit errors and Page/Block errors were evident in the patterns of upsets observed. It is likely that the Page/Block errors arise due to upsets in configuration registers in the memory array. Because the DUT was not actively exercised during the exposure, we could not determine exactly when a page/block error occurred, so cross sections are approximate for these error modes. Here and in the following discussion, bit errors are taken to be single bits, which are flipped, as a result of the interaction with incident ions, normally from zero to one. We do not have the physical to logical address mapping, which would allow us to look for multiple bit errors (error clusters) for these parts. However, in the overwhelming majority of cases of bit errors, there is only one error in a page, or one error in an entire block, which makes it extremely unlikely that there will be multiple errors from a single ion. This result is consistent with previously published results on the upset mechanism in flash memory—an ion passing through a floating gate creates a dense charge column, which creates a conducting path between the gate and substrate, which allows charge to leak off the floating gate. Since the ion only hits one gate at normal incidence, only one bit is affected. This situation is far different from that in volatile memories, where charge generated in the Si substrate can be shared across multiple

nodes. The only apparent multiple bit errors are cases where an entire page or a block (or a large part of one) upsets simultaneously—these page and block errors are attributed to errors in the control logic, rather than to the individual bits. These are counted as SEFIs (Single Event Functional Interrupt). In general, a SEFI is any event where the entire DUT, or a large part of it, stops working, presumably from an interaction with a single ion. As a practical matter, most of the SEFIs recorded here are either page errors or block errors, although some involve multiple pages or multiple blocks. Some are also watchdog errors, where the DUT simply stopped responding to commands.

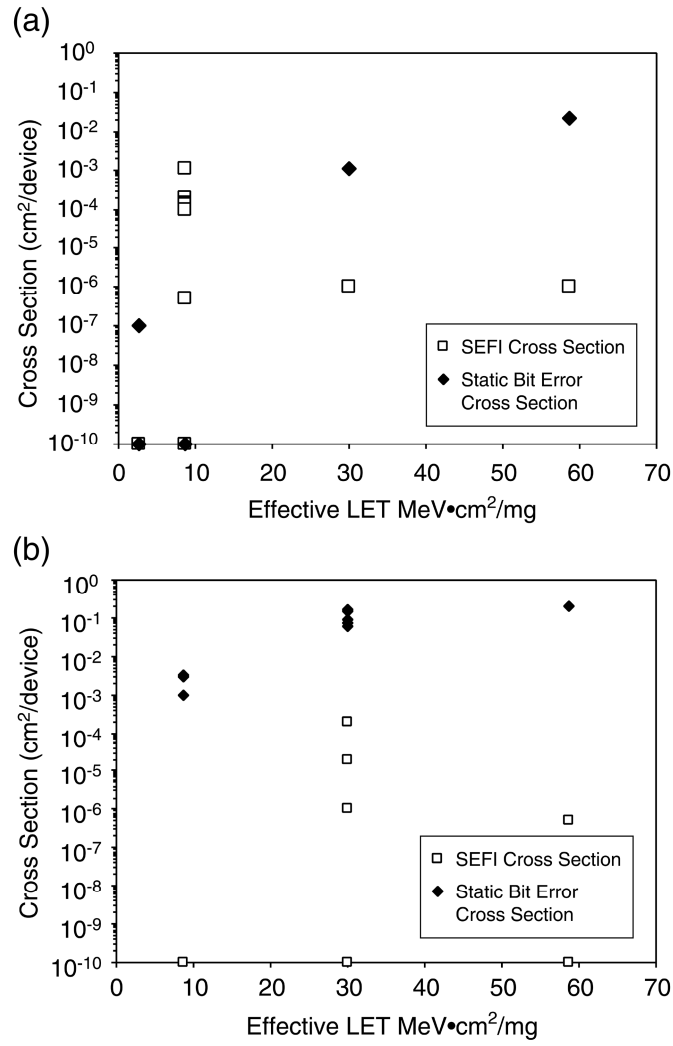
Fig. 5. Static upset cross sections: (a) Micron; (b) Hynix

The data in Fig. 4 is replotted in Fig. 5, normalized per device, instead of per bit, so that the SEFI effects can be shown on the same scale.

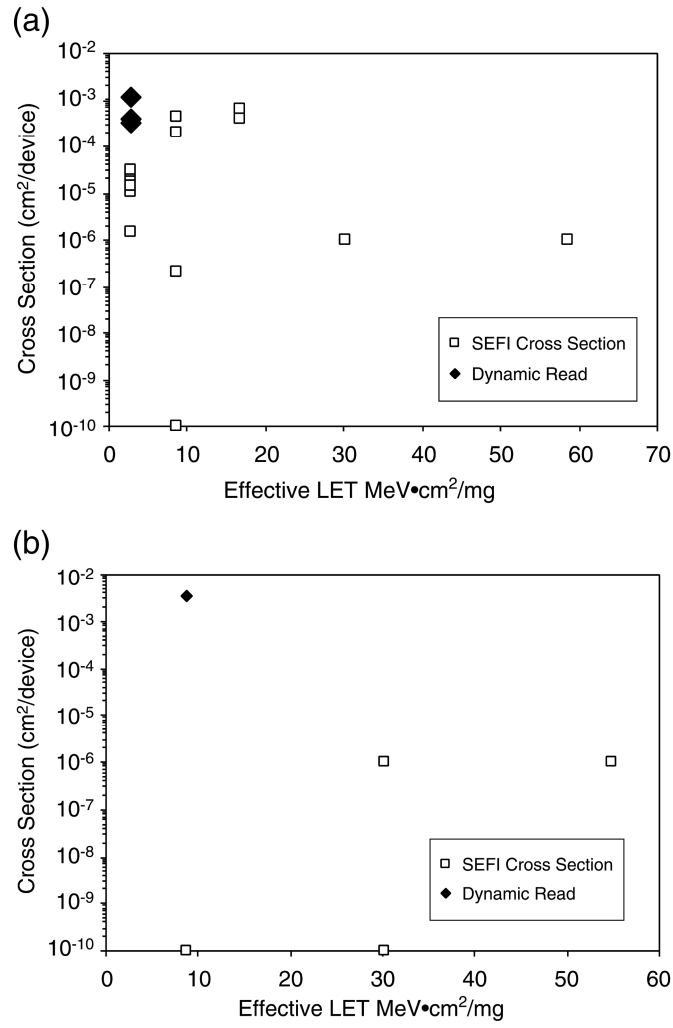
Fig. 6. Dynamic read upset cross section (a) Micron; (b) Hynix.

For the Dynamic Read condition, the parts showed exhibited transient read errors in addition to the bit and Page/Block errors, and other SEFIs, which are plotted in Fig. 6. For Ne and Ar ions (LET up to 9.74), there were no static bit errors at any LET, detected after the beam was turned off. There were transient read errors, as shown in Fig. 6, at these LETs, which are thought to be due to noise in the read circuit. At higher LETs (Cu, Kr, and Xe ions), SEFIs were observed on all shots for the Micron part, and many shots for Hynix parts, which made it difficult to count the transient errors—if the DUT stops responding to commands, it is hard to say what errors were not counted. And most of the errors that were counted, were due to control logic, and not associated with individual bits. After the DUT was restored to operating condition, it could still be checked for static bit errors, however. The transient results are shown in Fig. 6. Static results are not shown in Fig. 6, but they are consistent with results in Figs. 4 and 5. In Fig. 6, we have attempted to count SEFI events, despite the obvious difficulties of doing so. For example, one can count block errors, but it is often unclear whether multiple events are independent or not. We have assumed that block or page errors at widely separated addresses are independent events, and block or page errors at consecutive addresses are one event. Of course, if the DUT stops responding to commands, there may be other events that were missed completely. The number of SEFI events is small in any case. As always, the statistical uncertainty associated with rare events is large.

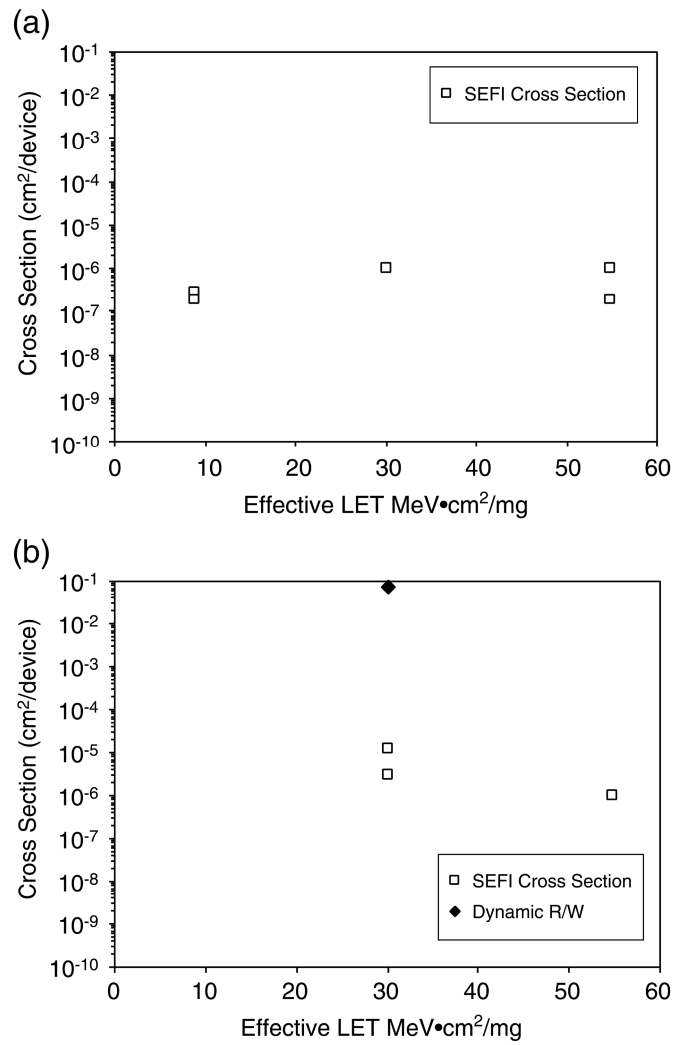
Fig. 7. Error cross sections observed in dynamic read/write testing (a) Micron; (b) Hynix.

Results of the dynamic R/W tests are shown in Fig. 7. Generally these results are unremarkable, because the usual zero-to-one errors are rewritten as they occur. For this reason, there are fewer errors indicated than in Fig. 6. The main reason for including this test was the expectation that the high voltage write operation would contribute to more errors in the control circuits, but this appears not to have happened, at least not on a large scale. Probably, this is because the write operation is performed only when a zero-to-one error is detected. For this circuit, four thousand such errors are still only one part per million of the entire memory, so the write circuit duty cycle is a very small number. Where a static cross section is given, it is based on the number of errors detected after the exposure and resetting of the DUT. The transient cross section is based on errors detected during the exposure. But some of the transient errors are probably really static bit errors that were rewritten during the test.

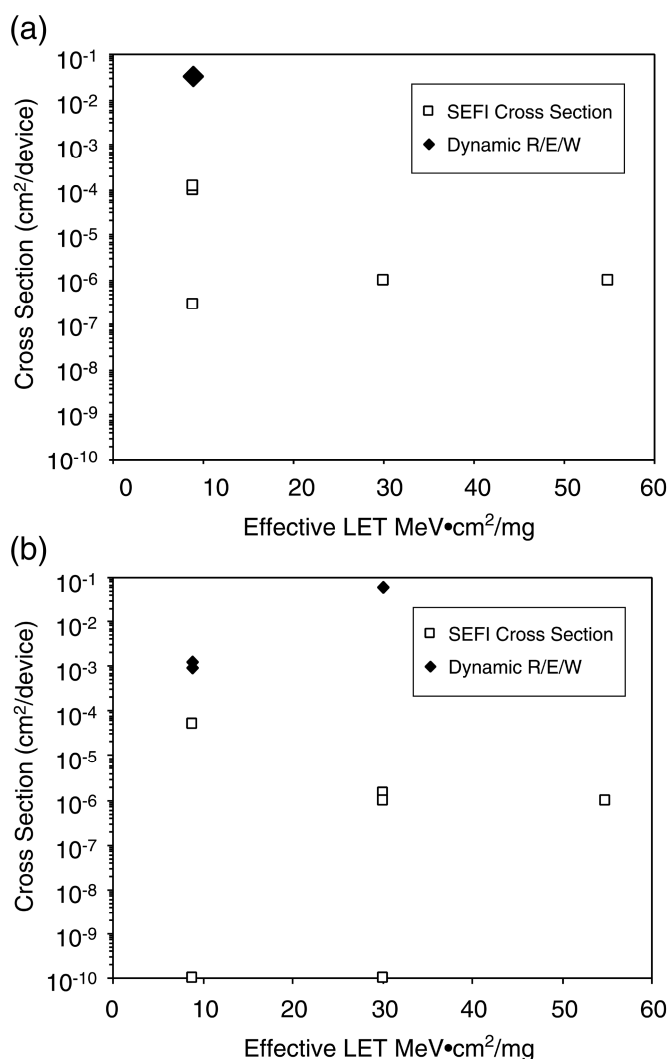
Fig. 8. Error cross sections observed in dynamic Read/Write/Erase testing (a) Micron; (b) Hynix.

Results for the dynamic R/E/W tests are shown in Fig. 8, to the extent that they can be determined. For this condition, there were many more SEFIs than in the R/W (without erase) mode, which is probably due to the fact that every block is erased and rewritten on every cycle, so that the duty cycle for high voltage operations is much higher. As a practical matter, there are many page and block errors, which usually appear to be independent, on almost every shot with LET at or above 9.74 (Ar). With many large chunks of the memory completely knocked out, it becomes impossible to determine static or transient errors affecting only single bits.
