DATE: October 10, 1997
TO: P. Huber/400
FROM: K. Sahu/300.1
SUBJECT: Radiation Report on: LM117HV
Project: GOES Sounder/Imager
Job #: M78297
Project part #: LM117HV

PPM-97-042

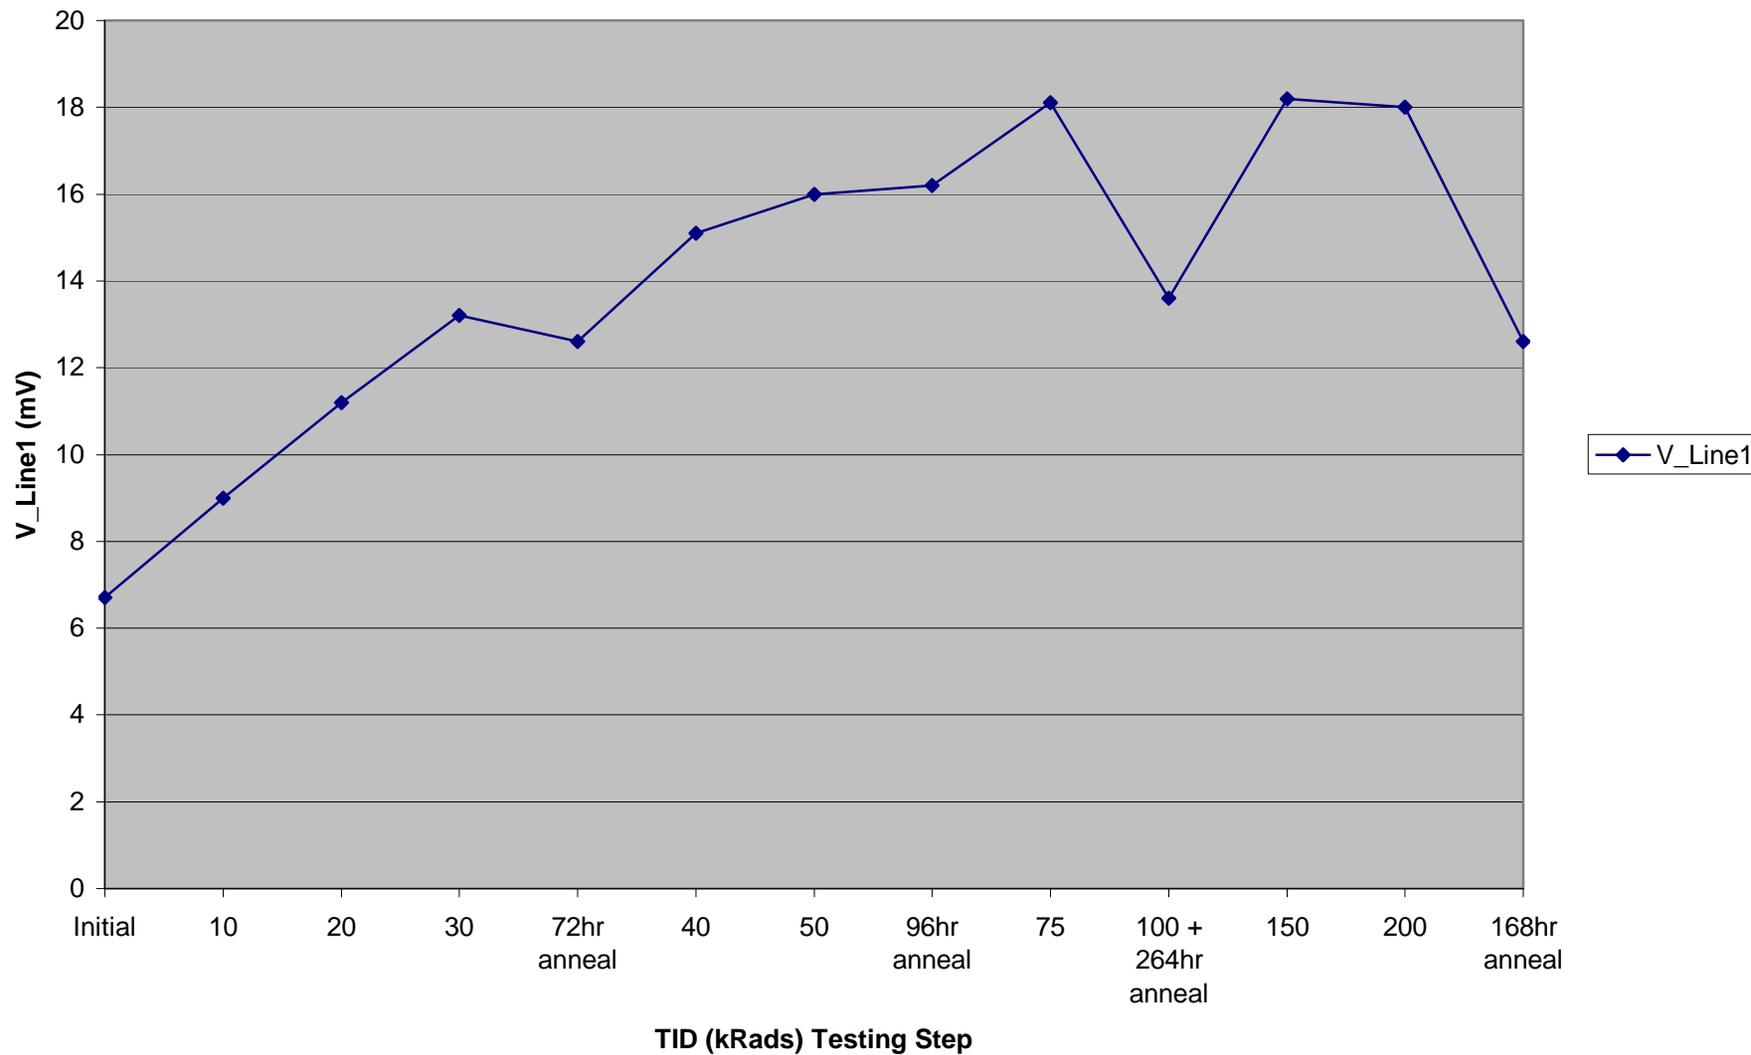
Figure 2: V_Line1(mean) vs Total Ionizing Dose

After the 20.0 kRad irradiation, SN's 251, 254 and 257 exceeded the specification limit of 11.4mV for V_Line1 with readings of 12.1, 11.5 and 11.5mV respectively. **All parts passed all other tests.**

After the 30.0 kRad irradiation, all parts exceeded the specification limit for V_Line1 with readings in the range of 11.5 to 14.8mV. **All parts passed all other tests.**

After the 75.0 kRad irradiation, all parts exceeded the specification limit for V_Line1 with readings in the range of 16.8 to 19.0mV. **All parts passed all other tests.**

After the 200.0 kRad irradiation, all parts exceeded the specification limit for V_Line1 with readings in the range of 17.3 to 19.6mV. **All parts passed all other tests.**

After the annealing the parts for 168 hours at 25°C, parts showed some recovery in V_Line1 with all parts readings in the range of 11.4 to 13.3mV.

V_Line1 was the only parameter that showed any degradation with radiation. Figure 2 shows the trend of V_Line1 after each radiation and annealing step.
