# SEE and TID Characterization of an Advanced Commercial 2Gbit NAND Flash Nonvolatile Memory

**Abstract**—An advanced commercial 2Gbit NAND flash memory (90 nm technology, one bit/cell) has been characterized for TID and heavy ion SEE. Results are qualitatively similar to previous flash results in most respects, but we also detected a new dynamic failure mode.

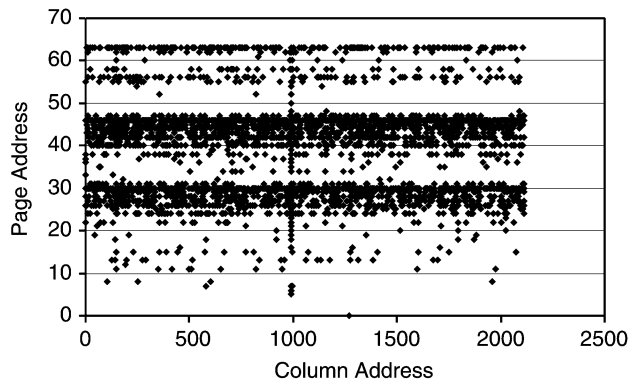
Fig. 6. Bit error map for initial static read, at 75 krad ( $\text{SiO}_2$ ). Non-random distribution indicates problems in peripheral circuits, rather than individual bits. Page address is also the row number.

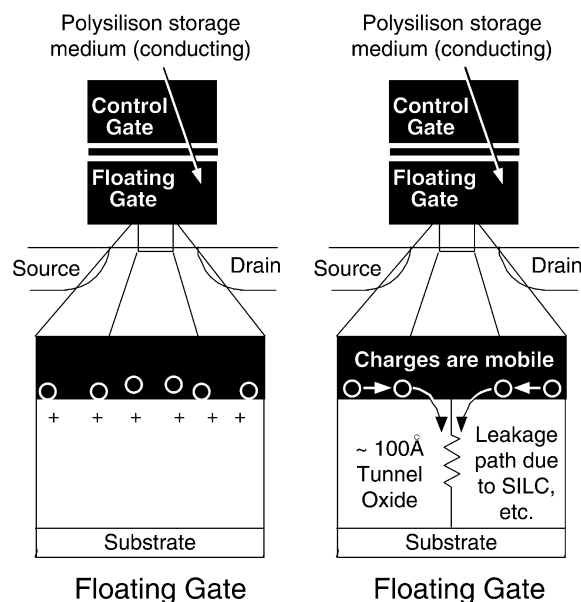
Fig. 7. Radiation damage mechanisms: (a) positive oxide charge; (b) oxide damage along an ion track, leading to a conducting path in the oxide.

The most common error in heavy ion testing is a single bit error, zero turned to one, when the ion passes through the floating gate. Positive oxide trapped charge, compensating the negative charge on the floating gate, is indicated schematically in Fig. 7(a), which is an attractive idea because of its simplicity. However, the actual physical charge loss mechanism, in a heavy ion strike, is more complicated, and it has been described in a number of previous reports [23]–[25]. Oxide damage from the ion strike, leading to a low resistance leakage path, as illustrated in Fig. 7(b), has been reported previously [24], [25], but it is not the focus of this work.
